# Investigation of the footprints of ecological criteria in a historical minority mansion in Kayseri Talas

Z. Özlem Parlak Biçer\*

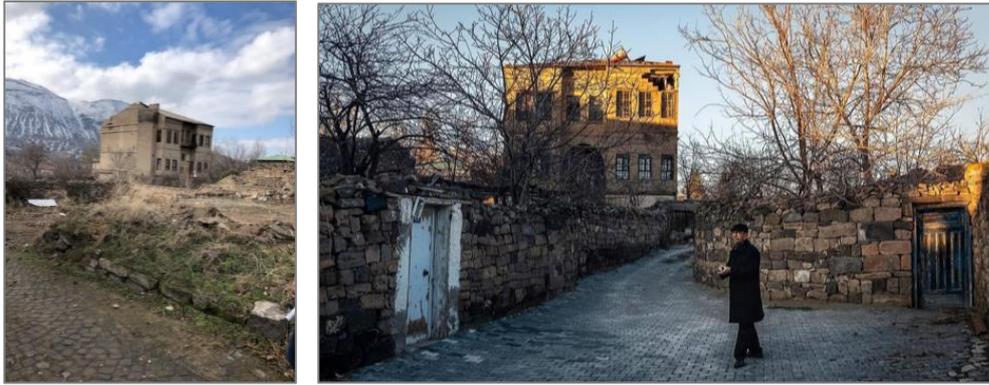
Figure 1, 2 Karaman Mansion (Parlak Biçer, 2020a) (Şenalp, 2019)

Karaman Mansion (Figure 1, 2), which is named after its first owners examined in the study, is one of the structures built in 1879 in a multi-national and religious ethnic structure. The change of ownership of the property, which is common in the minority residences, is also encountered in the Karaman Mansion. In the Cizye Defterleri dated 1834, the known person from the Karamanoğlu family, who was seen to reside in the neighborhoods where Karye-i Talas Millet-iRumiyan lived in Mahale-İ Yukarı (Cömert, H., 2010), is Gabriel Karamanoğlu. Robert Haroutunian reported that; his great great grandfather Kapriel Karamanian and his wife Gulkadin Khoubesserian were owner in Karaman Mansion. They had three children: Takuhi Karamanian Baliozian (1855-1936) Bedros Karamanian and my great grandfather Artin Karamanian (1860-1936) (Haroutunian, 2022). According to the land registry records (15.05.1947, 74 volumes, 103 pages, 01 rows and 07.05.1946, 176 volumes, 76 pages, 10 rows), Ohannes Karamanoğlu is the known owner of the property in the deed (Figure 3, 4, 5, 6). Afterwards, the mansion is seen under the ownership of Ahmet Karamancı and Kaniye Fevzioğlu. From the Fevzioğlu family, it was seen that it passed to Mehmet Ulutopçu by purchasing and to Mehmet and Mithat Ulutopçu by inheritance (Parlak, R., 2020). The current owner of the house is Ruşen Parlak. As it can be understood from here, the situation of being sold to many people in the old mansions is rare in this mansion. This situation; He ensured that the 143-year-old mansion was transferred to the present day with less damage and even without the complete destruction/partial destruction of other historical houses.

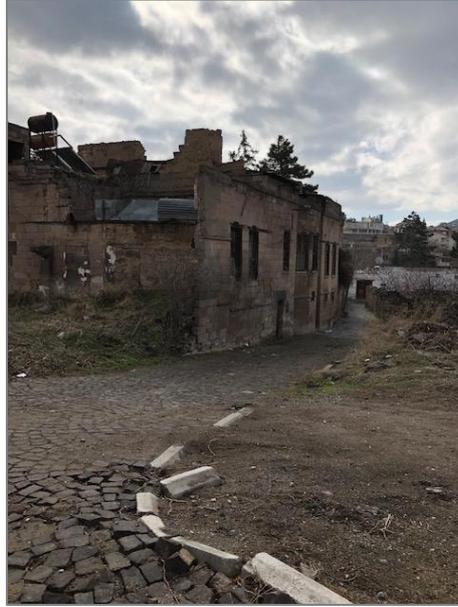
Figure 8 Gulbenkian mansion (Parlak Biçer, 2019)

Gulbenkian residence (Figure 8), located to the east of the land where the Karaman mansion is located, belongs to the family of Kalust Sarkis Gulbenkian, known as "Mr. Five Percent," in international business circles thanks to his oil shares. Although he was born in Istanbul, Gulbenkian (URL 1, URL 2, Tchamkerten, Astrig, 2017) is also relative to the Karaman family. As a result of the economic, political and war conditions of the period, both families settled in the USA by following different paths.

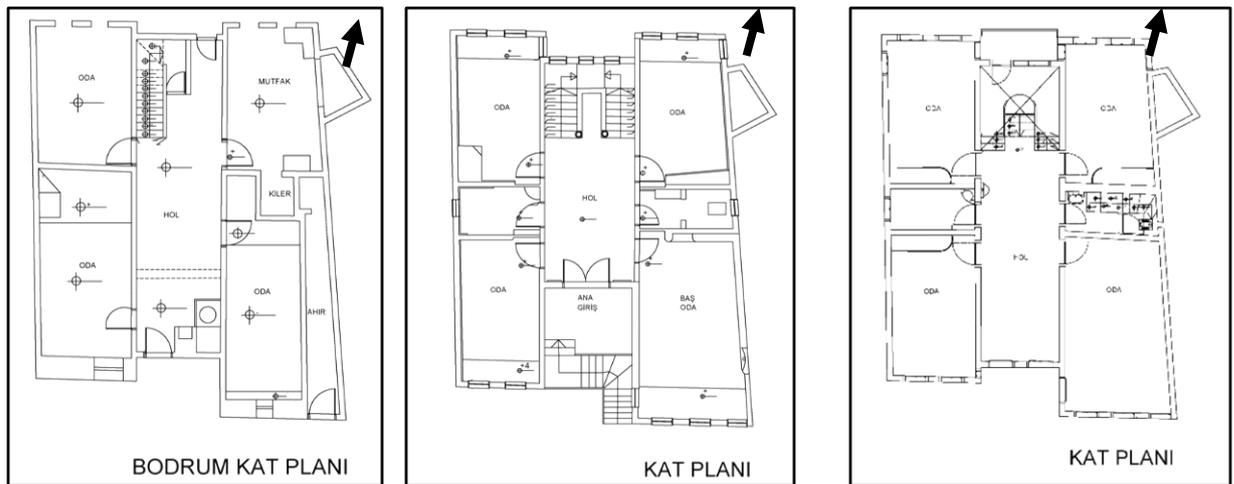
Figures 9, 10, 11 Basement, Main and First Floor Plans of Karaman Mansion (Parlak Biçer, 2020b)

The main entrance to the garden of the building is in the direction of the garden gate on Firin Sokak. At the garden level, there are places frequently used by those who serve the residential life, such as the outbuildings, barns, and kitchens of the building (Figure 9). There is a secondary use staircase descending below this level and there are two small rock-carved warehouses where the residence is used as a cold storage. In one of these warehouses, there is a “şirahna” (the local pronunciation of the word şirahane for using grape jam and wine), where grapes collected from the residential garden and other vineyards are crushed and their juice is extracted. There is also a door opening to the north garden section from this level in order to facilitate the life intertwined with the garden (Figure 9). These spaces, which are at the same level as the garden and street level, are not used for the main entrance. The main entrance is provided from an upper floor, which is reached by ostentatious stairs (Figure 10). There are four large rooms around a large hall on the main living floor, and two service areas, one of which is thought to be used for the service of the prepared food in the basement kitchen, and one is the place where a toilet was added later. The upper floor is reached by a two-armed staircase. On the upper floor, there are four rooms around a large hall (Figure 11). There is a wooden staircase leading to the roof of the building from one of the two small spaces between the rooms. It is thought that the roof and this ladder were added later by the second users.

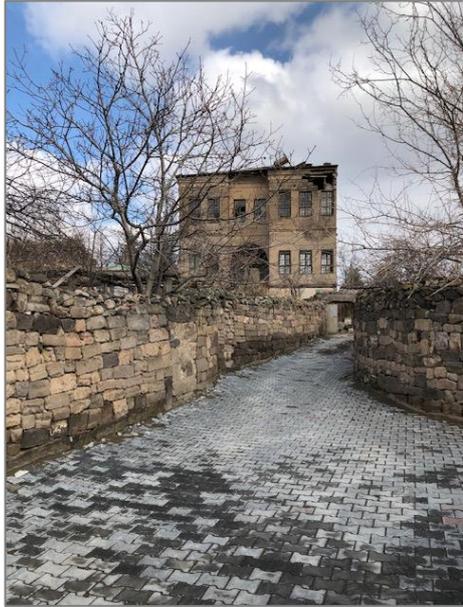
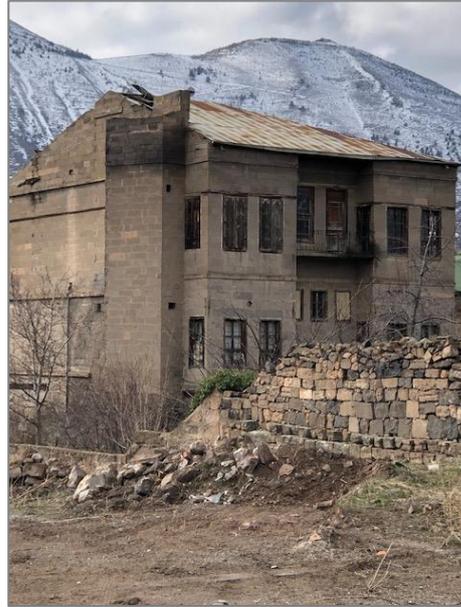
Figures 12, 13 The south and north facades of the mansion (Parlak Biçer, 2020a)

The main spaces of the building, like the main entrance of the building, are oriented to the north and south. This situation is also reflected in the facade layout. On the south façade facing Mount Ali, two or three window openings were made on both main floors, depending on the size of the meanders. The entrance and the space above it are emphasized by pulling in (Figure 12). There are also openings on the northern façade of the building. However, it is less in number compared to the south facade (Figure 13). There are no openings on the east and west facades of the mansion (Figure 14, 15). There are no window openings on the western façade as it is a single storey adjacent building. The absence of windows on the eastern façade of the building, which overlooks the garden area, suggests that the first users of the house wanted to build another house in the future. Because it is seen that the necessary labor has been done in order to add to the carrier parts on this facade.

It is seen that there are fewer and smaller openings on the northern façade of the mansion. In addition to having more openings on the south façade, the skylights on the upper part of the main entrance door of the mansion and in the south rooms are positioned for natural ventilation in the rooms heated by the sun in summer. There are also wooden shutters that provide cold control, especially on the north facade (Table 1).

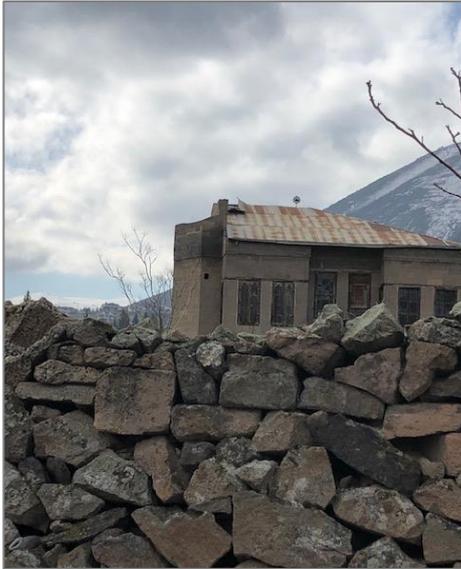
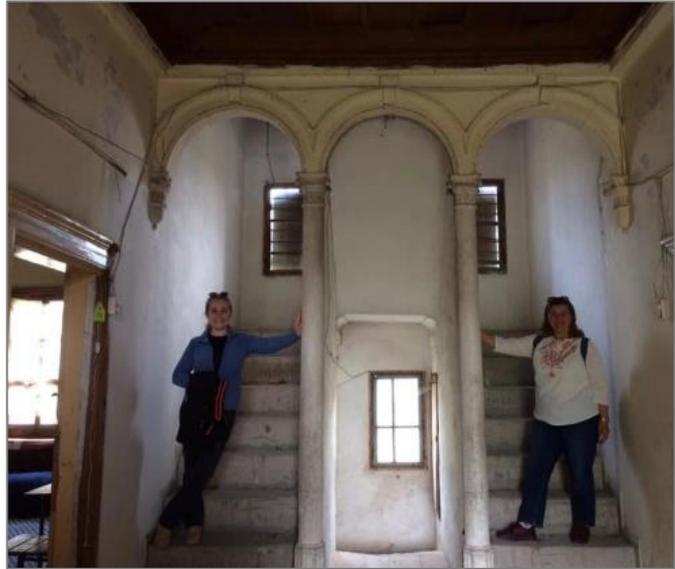
Figures 16, 17 Use of stone as building material on exterior walls and interior stairs (Parlak Biçer, 2019)

Local stone material was used as construction material in Karaman mansion. This material is seen not only for the carriers of the building, but also on the garden walls as a divider (Figure 16). It is thought that the roof of the building was created by the second users with metal elements. Because it is seen that the historical houses in Talas had a terrace roof when they were first built,

and these terraces were turned into roof shapes such as cradles and hipped roofs by closing them with sheet metal later on (Figure 17). Stone, which is the main construction material, was used in the load-bearing walls and partition walls by cutting it to a certain size, as well as being used in different parts of the building by processing a single piece for decorative purposes (Figure 18). This type of usage is encountered in the direction of the three-armed stairs, which reach the upper floor from the main entrance floor, facing the main entrance door and hall. There is a total of two street gates, one which is thought to be in use, and one left by brickwork, which reinforces the impression that another residence is planned to be built next to the mansion in the future, at the transition of the mansion to the streetatan garden. While an arch is made of cut stone in the garden corner, which has been closed for use (Figure 19), a single piece of stone jamb and lintel can be seen in the used one (Figure 20).

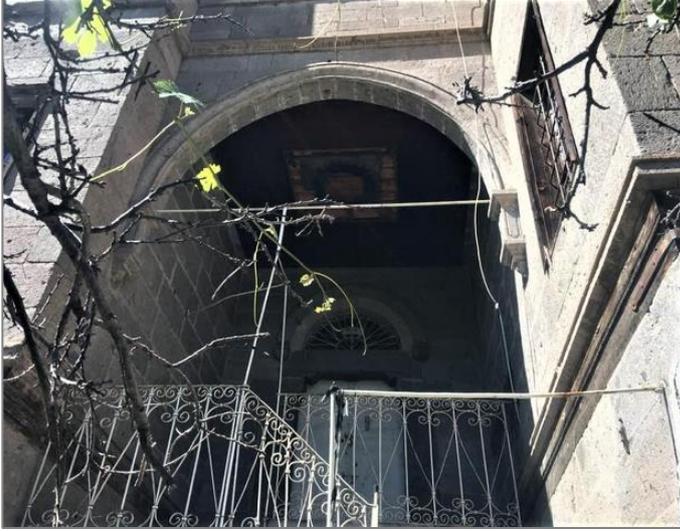
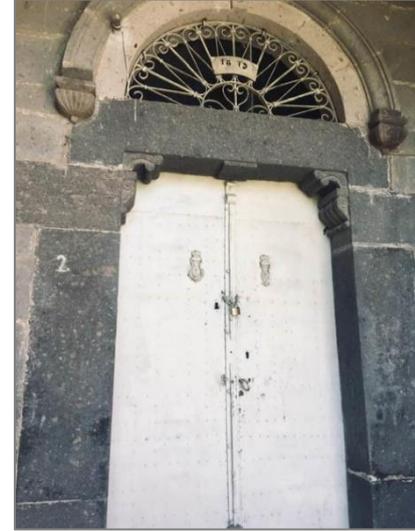
Figures 20, 21 Residence Main Entrance and Main Entrance Gate (Şenalp, 2019)

There are stairs leading to the main entrance of the mansion, an arch above the main entrance that also carries the floor, and a single piece of cut stone on the main entrance door with outstanding workmanship (Figure 20). The fact that the color of the stones around the main entrance of the building, which also emphasizes the entrance, is different from the stones used throughout the building, shows that these stones were obtained from a different quarry in the region (Figure 21). On the main entrance door, there is the construction year of the building, which is integrated with the ironwork. These details are also decoratively reflected on the rose window, which is used for the illumination and ventilation of the space, located on the entrance door (Figure 22). Stonework can also be seen on the items made as a single piece for squeezing grapes and detailed with embroideries on them (Figure 23).

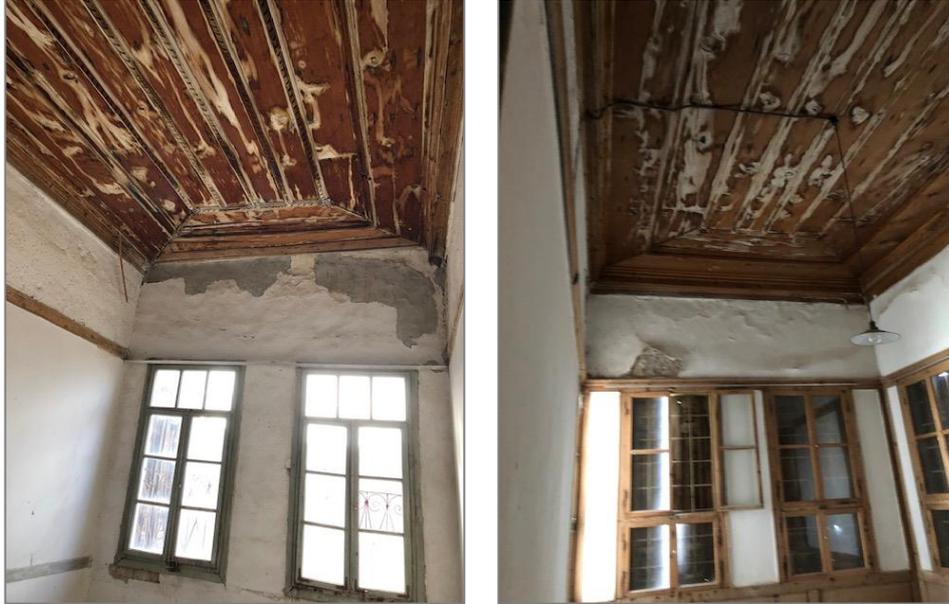
Figures 24, 25 Room interiors located to the south and north (Parlak Biçer, 2020a)

Wooden beams were used as carriers in the main entrance and first floor floors of the building. While stone covering material was used on these beams on both the main floor and the first floor,

wooden sweat ceiling was applied as the ceiling covering (Figure 24). Based on the wooden decorative ornaments on the ceiling of some residential buildings, which were restored by the municipality, it is thought that this mansion also had ceiling decorations and disappeared over time due to weather conditions, people's dismantling, and moving to another place. The wood used as a beam on the load-bearing walls also acts as a lintel on the window openings. Windows are made of wood in a double-opening manner (Figure 24, 25). There are wooden shutters on the outside of the windows (Figure 25). These blinds, especially located on the north facade windows, contribute to protection from the cold in winter (Figure 26).
